Manhole Inspection Summary

Manhole # S11M__011MH

Location Address: **3160 Leeds St**

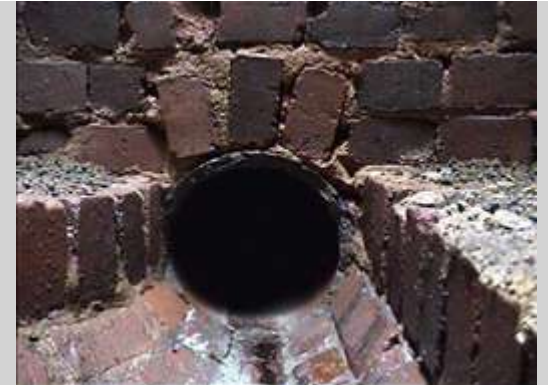
12 O'Clock Outflow

8 in. Circular Gravity Sewer
Pipe Out @ 12 O'Clock

Pipe Height: **7.2** (in.) Rod and Bar (Angled)
Pipe Material: **Clay** ☐ Pipe Lined
Invert Depth: **9.65** (ft.) Flow Characteristics: **Slow**
Deposits: ☒ None ☐ Mud ☐ Sludge ☐ Debris ☐ Grease
Silt Depth: **0** (in.) Deposits Extent:
Infiltration: **None** Pipe Seal Cond: **Sound**

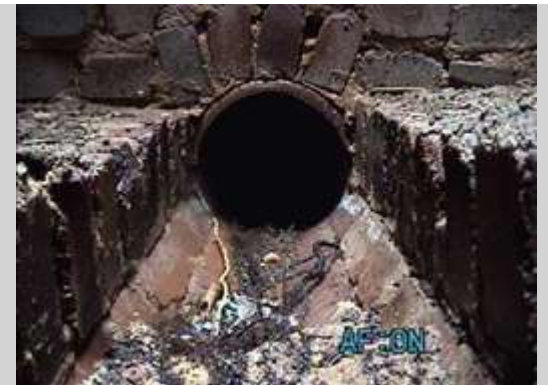
6 O'Clock Inflow

8 in. Circular Gravity Sewer
Pipe In @ 6 O'Clock

Pipe Height: **8.4** (in.) Rod and Bar (Angled)
Pipe Material: **Clay** ☐ Pipe Lined
Invert Depth: **9.52** (ft.) Flow Characteristics: **None**
Deposits: ☒ None ☐ Mud ☐ Sludge ☐ Debris ☐ Grease
Silt Depth: **0** (in.) Deposits Extent:
Infiltration: **None** Pipe Seal Cond: **Sound**

Connects To: **Stub connection / abandoned**

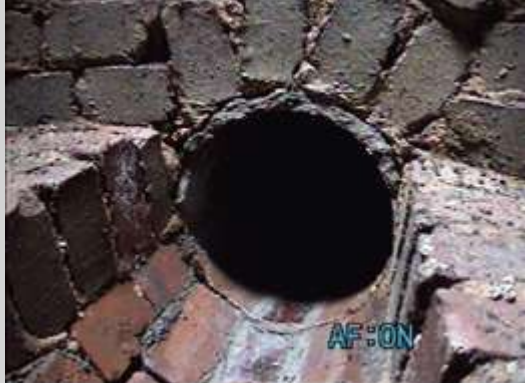
9 O'Clock Inflow

8 in. Circular Gravity Sewer

Pipe In @ 9 O'Clock

Pipe Height: **8.4** (in.) Rod and Bar (Angled)

Infiltration: **None** Pipe Seal Cond: **Sound**
